**KIRKWOOD MEADOWS  
PUBLIC UTILITY DISTRICT  
2025 WATER MASTER PLAN**

**MARCH 2025**

**2025 WATER MASTER PLAN**

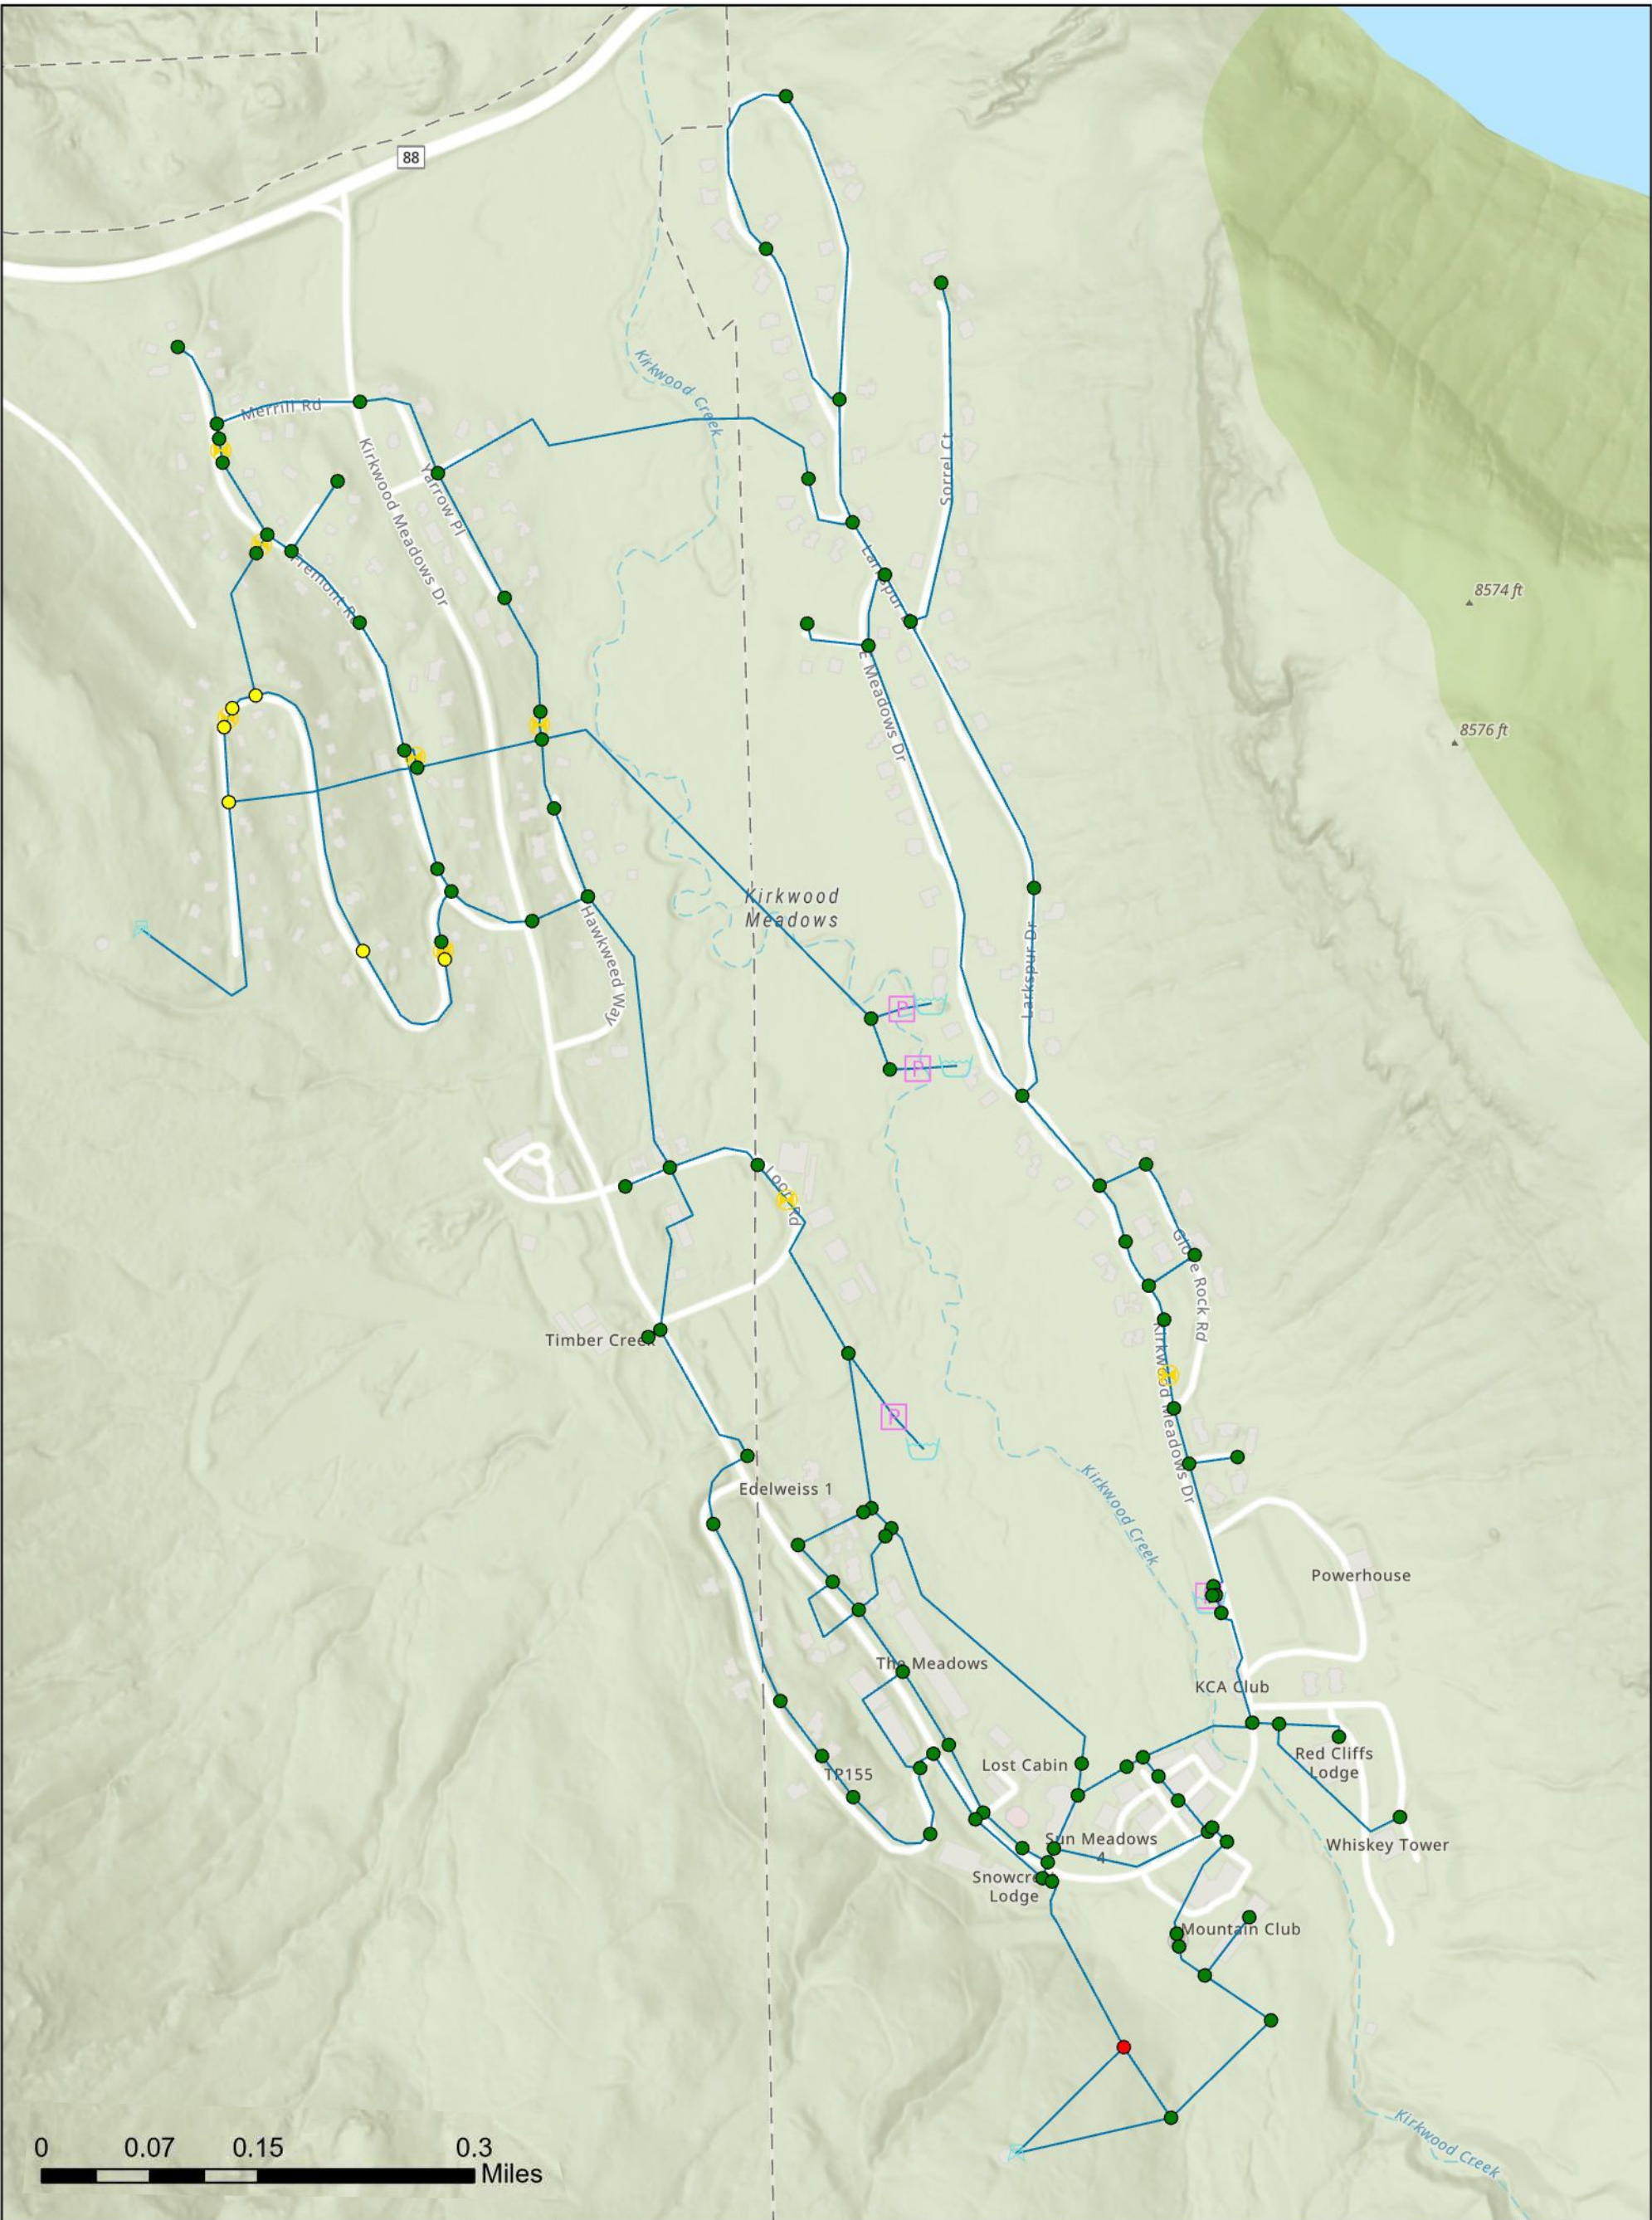
Figure 6-1 presents the available fire flow during existing system MDD on the existing distribution system. The modelling results indicate that only seven of the nodes cannot serve their assigned fire flow demand of 1,500 gpm. The main area with the fire flow deficiency is near the Dangburg tank on the northwest portion of the system. There is an additional node with fire flow deficiency on the south side of the system, near Lodge Tank.

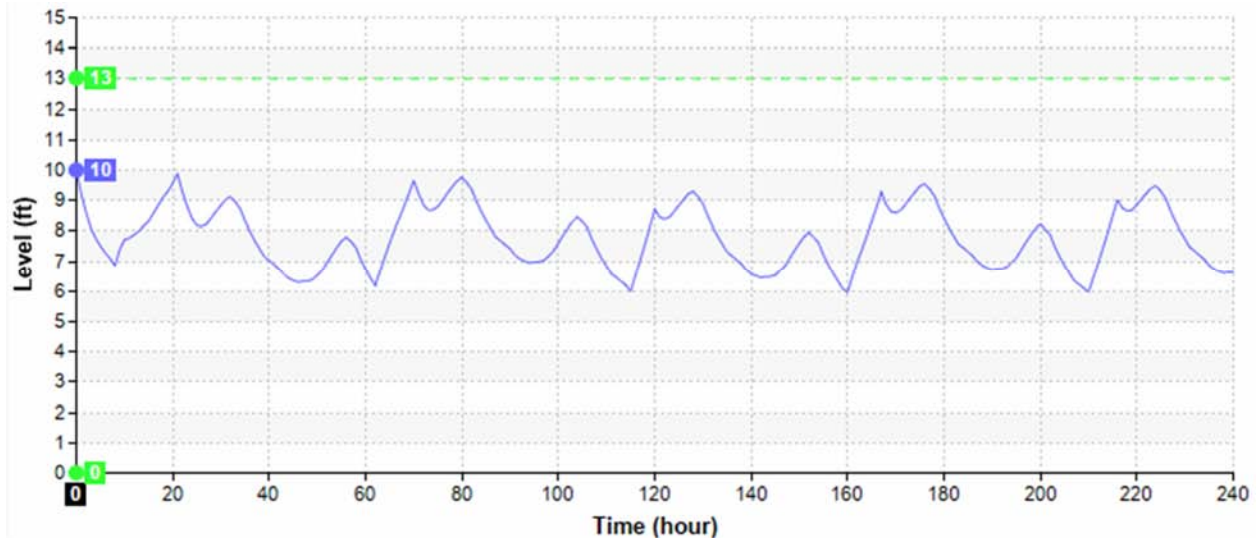
Figure 6-3: Dangburg Tank Turnover

An extended period simulation over 10 days was run on the existing model under the MDD scenario. Figure 6-3 and Figure 6-4 show the tank turnover for Danburg Tank and Lodge Tank, respectively. The figures show that neither tank is currently able to fully fill or empty when the pumps are operating on system pressure. To simulate the worst-case scenario for water age, the model was also run under the ADD condition. Figure 6-5 and Figure 6-6 show the water age over the extended period simulations on the Dangburg Tank and Lodge Tank, respectively. The water age at Dangburg Tank reaches a maximum of 123 hours (5.2 days) at 8.7 days into the simulation period. The water age at Lodge Tank increases at a constant rate throughout the simulation, reaching approximately 209 hours (8.7 days) by the end of the 10-day simulation. This indicates that Lodge tank may have a current water age issue.

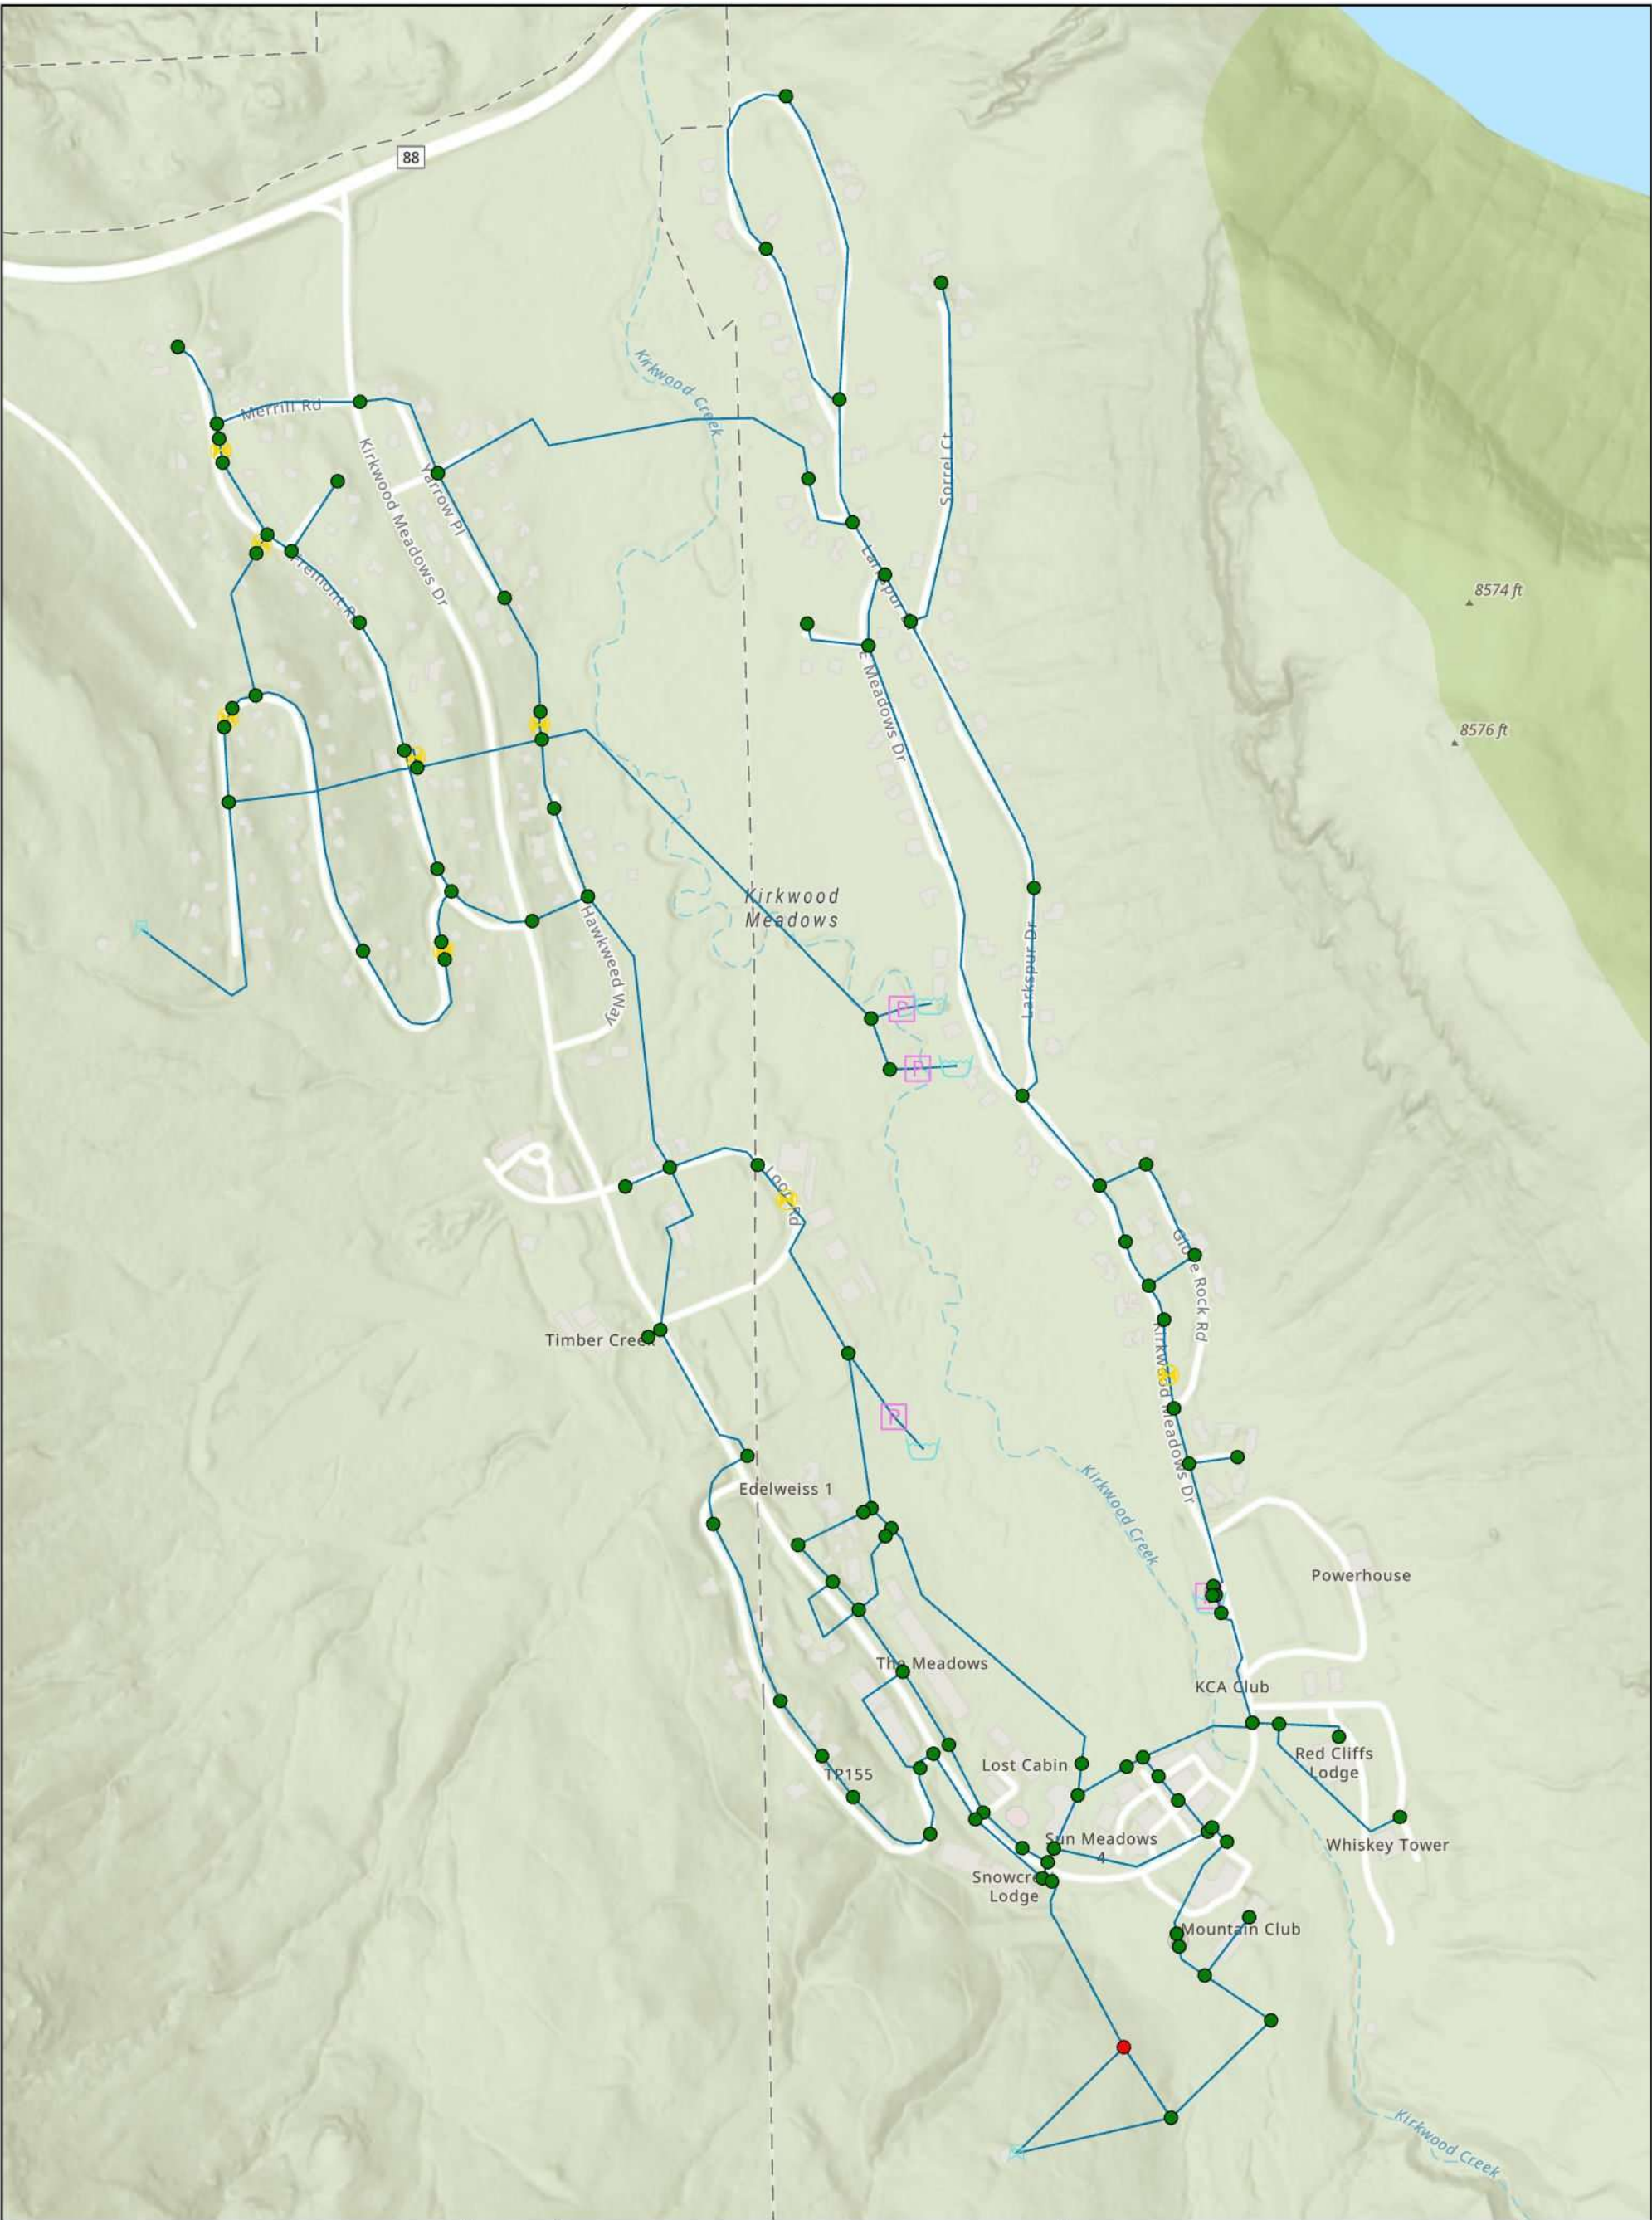
Figure 6-13: Buildout Scenario 1 - Available Fire Flow

Figure 6-13 shows the available fire flow for this scenario. The only node that does not meet its designated fire flow requirements is the node located on the inlet side of Lodge Tank – this is likely due to its proximity to the tank. The results under this operational strategy show improvements from the seven deficient nodes under the existing condition. When PRV's 1, 2, and 5 are active, the system pressures do not require them to open – this creates dead ends in the system which leads to deficient fire flow in those areas. When PRV's 1, 2, and 5 are open, those dead ends are eliminated.

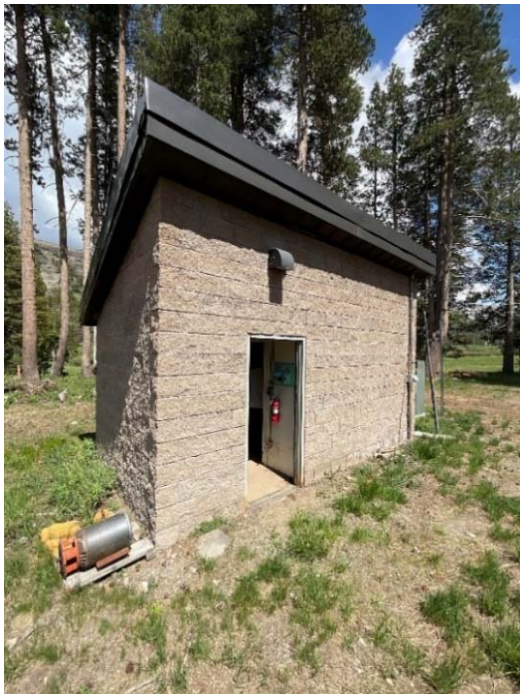
Well 3 was constructed in 1992 and is located south of the District offices on the west side of the meadow. The well is outfitted with treatment and a secondary booster pump that rest inside an existing CMU block building (see Figure 7-1). Currently, this well is operated manually and has no automatic controls. Operational upgrades are planned for this well site, including the installation of a PLC and control panel, a wireless modem, and a level transducer. Further details on these improvements can be found in Chapter 8 – Recommended Capital Improvement Projects.

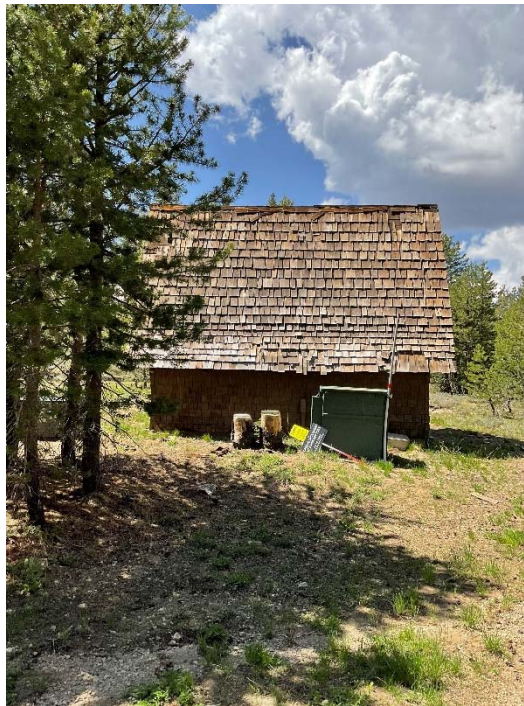
Wells 4 & 5 have also been found to have high levels of manganese above the State's maximum contaminant level. Per the District's corrective action plan provided to the Division of Drinking Water, a feasibility study must be conducted for the implementation of a green sand filter that would effectively reduce manganese levels in the before entering the system. Preliminary filter sizing and backwash disposal estimates can be found in Chapter 8 – Recommended Capital Improvements Projects.

**Figure 7-2: Wells 4 & 5 Wooden Treatment Building**

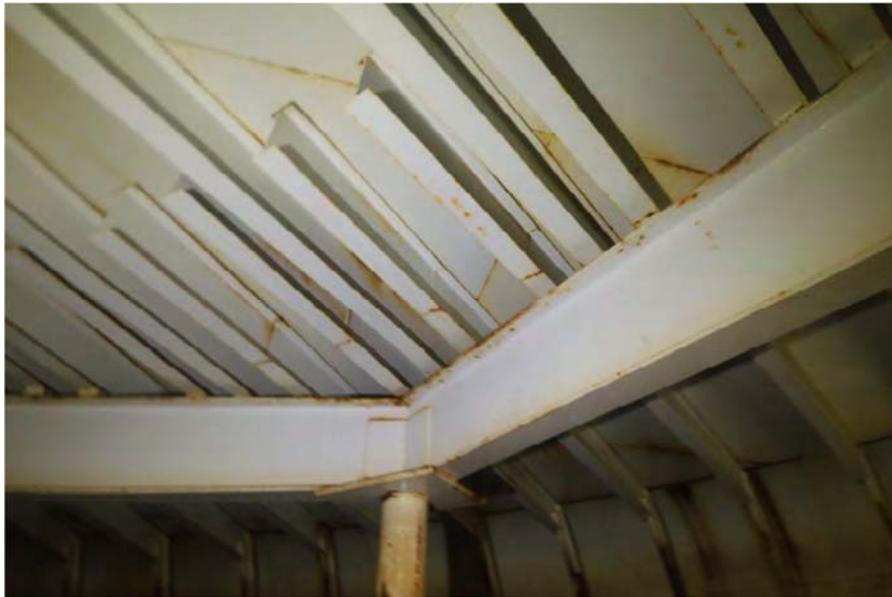
The coating on the underside of the roof plates was determined to be in overall poor condition and worse than the rest of the interior. Corrosion was found common to the edges of the support member flanges and roof plates. Spot peeling and cracking was observed throughout. Although the shell surfaces are covered with a dark sediment, spot checking revealed the lining of the shell to be in good condition with minor areas of dark rust mainly found below the high-water level. The floor had a moderate load of sediment upon it, but spot checking revealed an epoxy system that was estimated to be in good condition. Corrosion pitting locations were uncovered on the floor and were patched during the inspection by CSI. Prior patches identified were observed to be performing properly. Figure 7-3 and Figure 7-4 present examples of the tank's roof and floor condition.

**Figure 7-3: Lodge Tank Interior Roof**

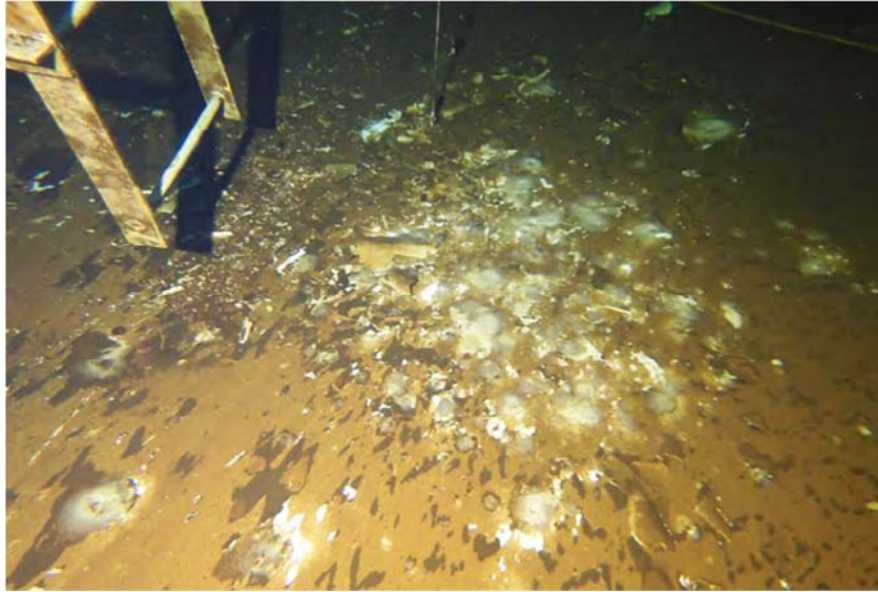
**Figure 7-4: Lodge Tank Interior Floor**

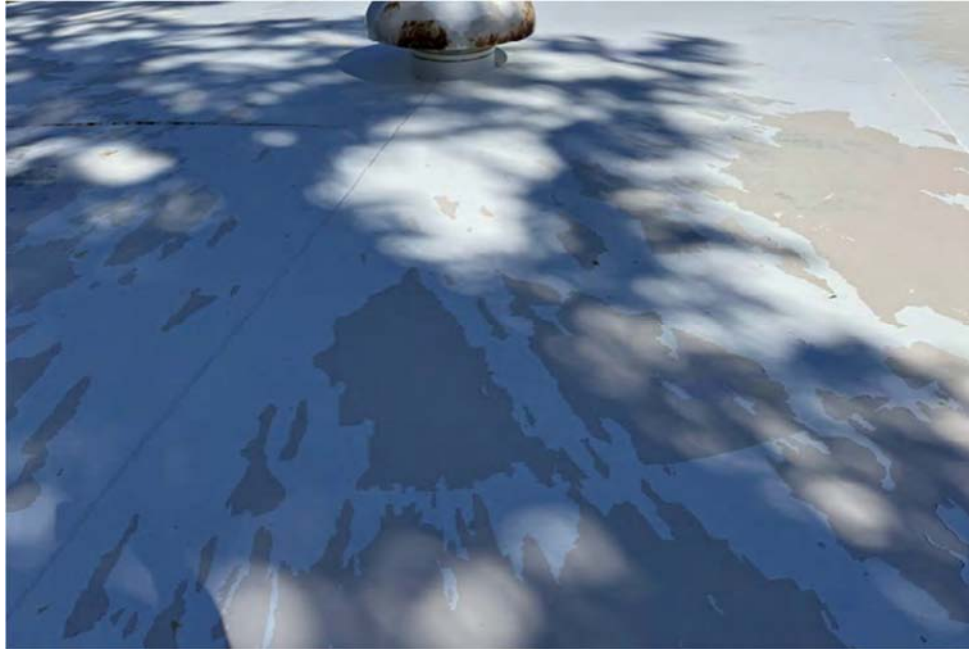
The exterior roof is highly weathered and was determined to be in overall fair condition. The exterior shell is in good condition. There is moderate chalking present on the entire tank as well as dark rust in areas that have been mechanically damaged from operations or vandalism. Figure 7-5 and Figure 7-6 show examples of the condition of the tank's exterior roof and the thickness of the paint on the tank's shell.

**Figure 7-5: Lodge Tank Exterior Roof**

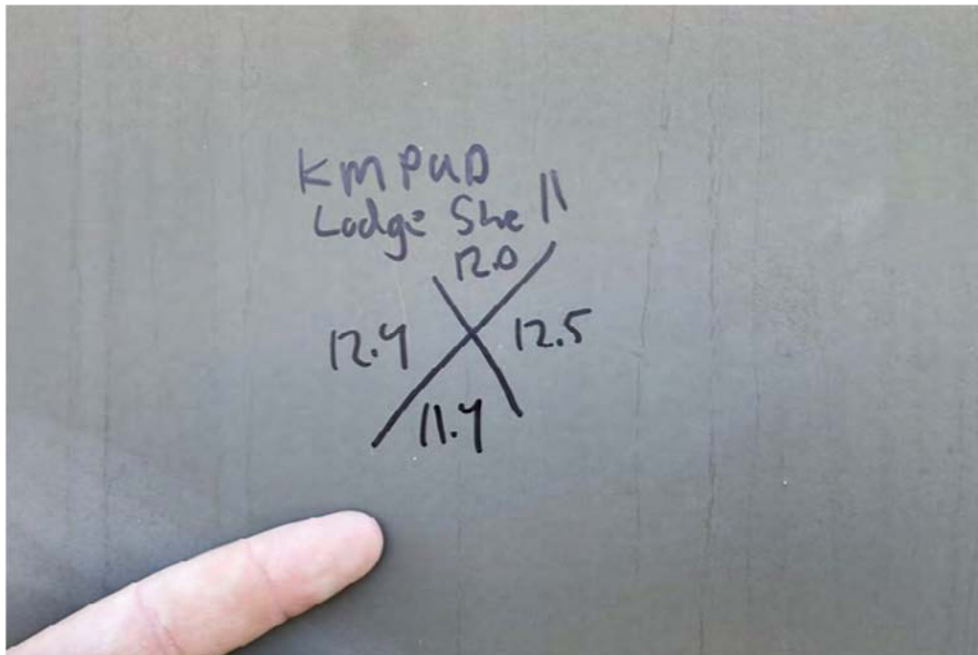
**Figure 7-6: Lodge Tank Shell Paint Thickness**

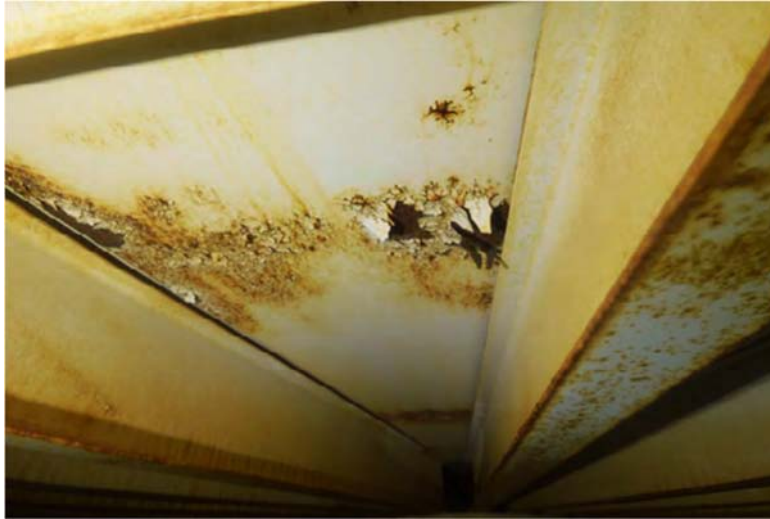
The coating on the underside of the roof plates was determined to be in overall poor condition and worse than the rest of the interior. Corrosion was found common to the edges of the support member flanges and roof plates. Spot peeling, cracking, exfoliation and structural loss was observed throughout. Although the shell surfaces are covered with a dark sediment, spot checking revealed the lining of the shell to be in good condition with minor areas of dark rust mainly found below the high-water level. The floor had sediment upon it, but spot checking revealed an epoxy system that was estimated to be in good condition. Corrosion pitting locations were uncovered on the floor and were patched during the inspection by CSI. Prior patches identified were observed to be performing properly. Figure 7-7 and Figure 7-8 present examples of the tank's roof and floor condition.

**Figure 7-7: Dangburg Tank Roof Interior**

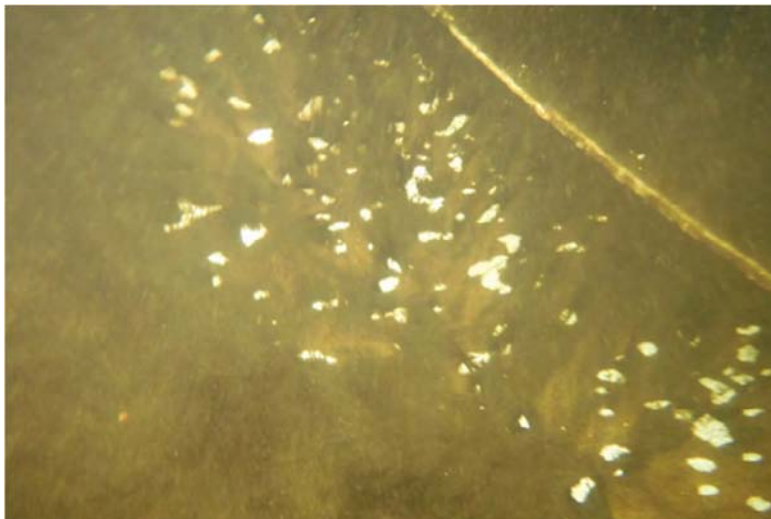
**Figure 7-8: Dangburg Tank Interior Floor**

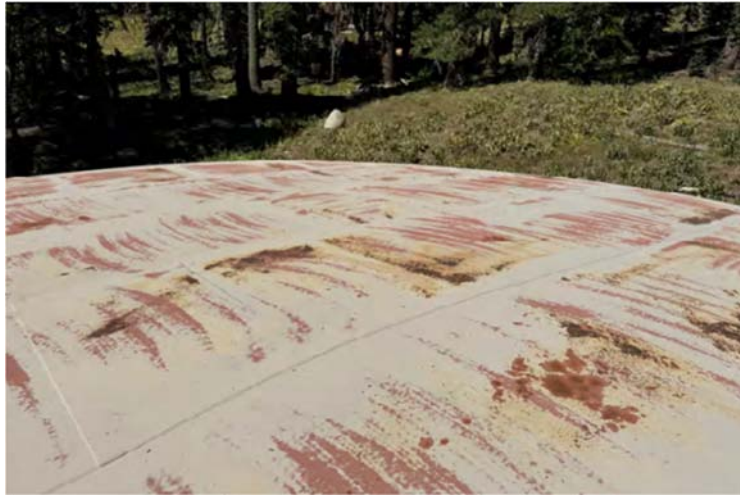
The exterior roof is highly weathered and was determined to be in overall poor condition. The exterior shell is in good condition. There is moderate chalking present on the entire tank as well as dark rust in areas that have been mechanically damaged from operations or vandalism. The paint thickness was found to range from 7.0 to 8.0 mils on the roof and 11 mils on the shell, and the paint was estimated to exhibit satisfactory adhesion. Figure 7-9 and Figure 7-10 show examples of the condition of the tanks exterior roof and the thickness of the paint on the tank's shell.

**Figure 7-9: Dangburg Tank Roof**

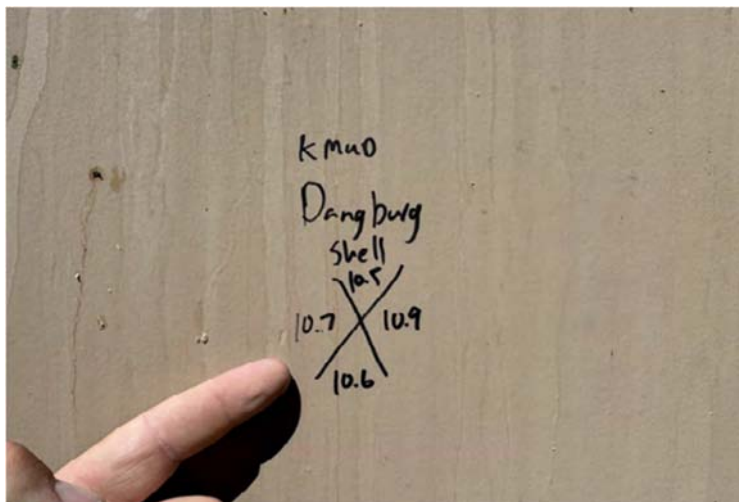
**Figure 7-10: Dangburg Tank Shell Paint Thickness**
