**KIRKWOOD MEADOWS  
PUBLIC UTILITY DISTRICT  
2025 WATER MASTER PLAN**

**MARCH 2025**

**2025 WATER MASTER PLAN**

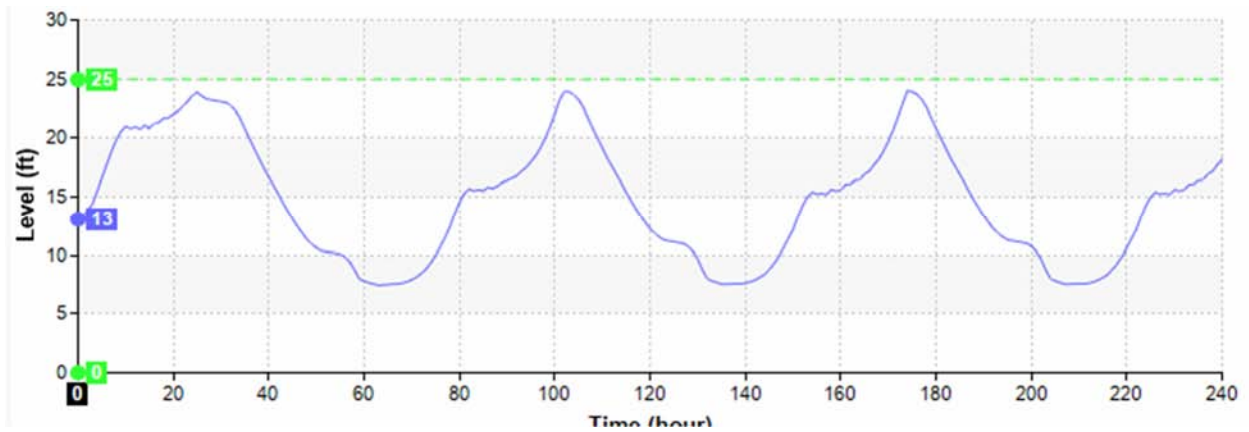
Figure 6-24: Lodge Tank Turnover Scenario 2

Figure 6-23 and Figure 6-24 show that the tank Turnover for both Dangburg and Lodge Tanks is improved under this scenario. Both tanks experience full fill and empty cycles throughout the simulation.

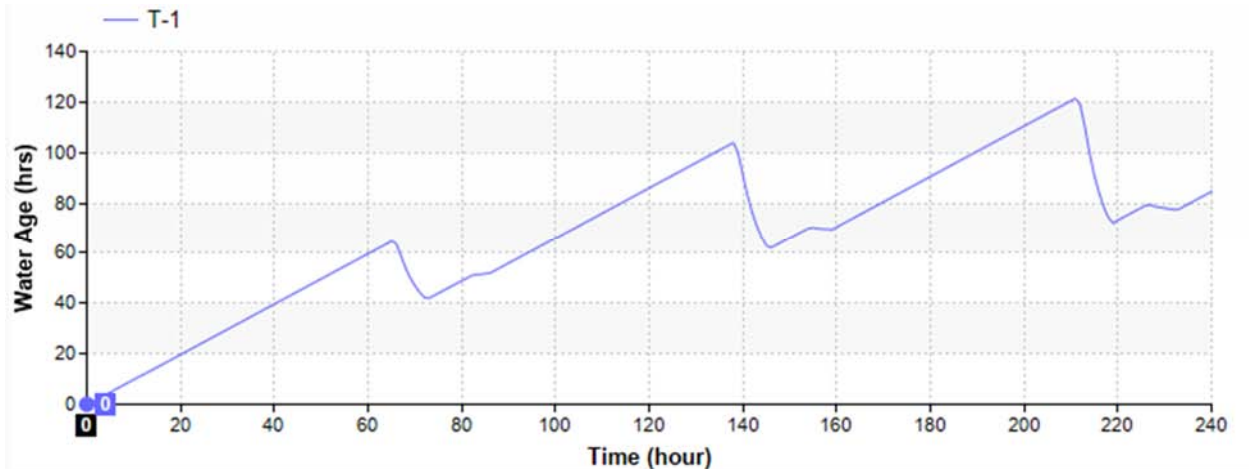
Figure 6-25: Dangburg Tank Water Age Scenario 2

To simulate the worst-case scenario for water age, the model was also run under the Buildout ADD condition. Figure 6-25 shows that the water age at the Dangburg Tank peaks at 119 hours (5 days) around 8.8 days into the 10-day simulation. This water age is higher than the water age at the Dangburg Tank under Scenario 1 (3.5 days). Figure 6-26 shows that the water age at Lodge Tank Peaks is improved by the increased turnover in the tank. The water age cycles throughout the simulation and experiences a peak of 83 hours (3.5 days) at approximately 8.8 days into the 10-day simulation period. The water age for Lodge Tank shows a significant improvement under this operational scenario.
